# NAPC FORUM PHILADELPHIA, PENNSYLVANIA

## Integrating Sustainability and Design Review – A New Trend in Guidelines

#### Developing Sustainability Guidelines for Historic Districts

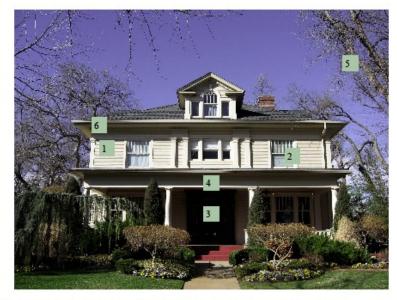
This Colonial Revival style house at 617 NW 14th Street illustrates several features that enhance energy efficiency.:

- Light colored exterior for reflectivity.
- 2. Operable windows for ventilation.
- 3. Generous floor to ceiling ratio allows heat to rise away from living space.
- 4. Porch provides shade across entire façade.
- 5. Deciduous trees provide summer shade.
- 6. Wide eaves provide additional shade.

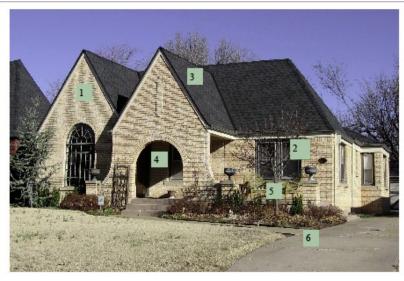
This Tudor Revival style house at 705 NW 42nd Street illustrates several features that enhance energy efficiency.:

- 1. Light colored exterior for reflectivity.
- 2. Operable windows for ventilation.
- 3. Steep roof allows for heat to rise away from living space.
- 4. Porch provides shade.
- 5. Deciduous trees planted to provide summer shade.
- 6. Light colored concrete on the driveway and walkway for reflectivity.

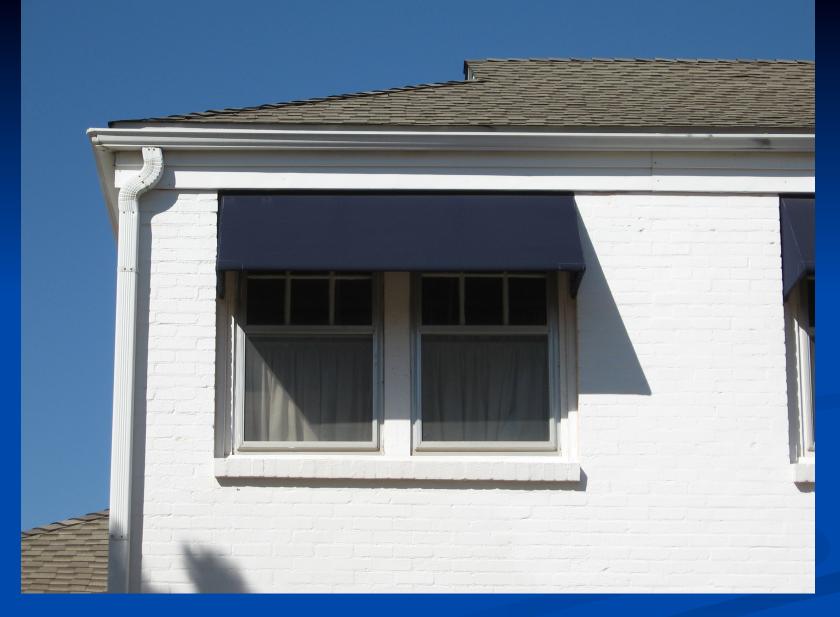
**Inherent Energy Conservation – Use of Awnings**

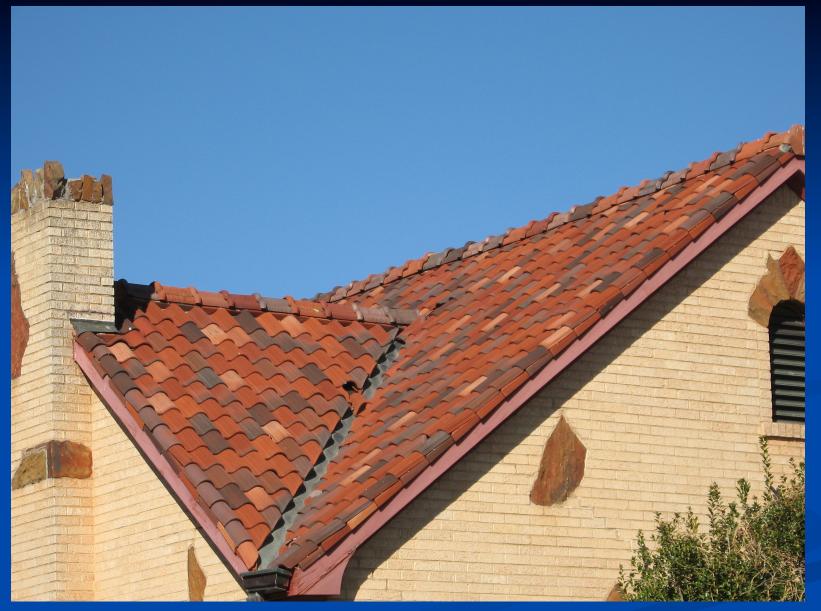
**Inherent Energy Conservation – Longevity of Materials Clay Tile Roof**

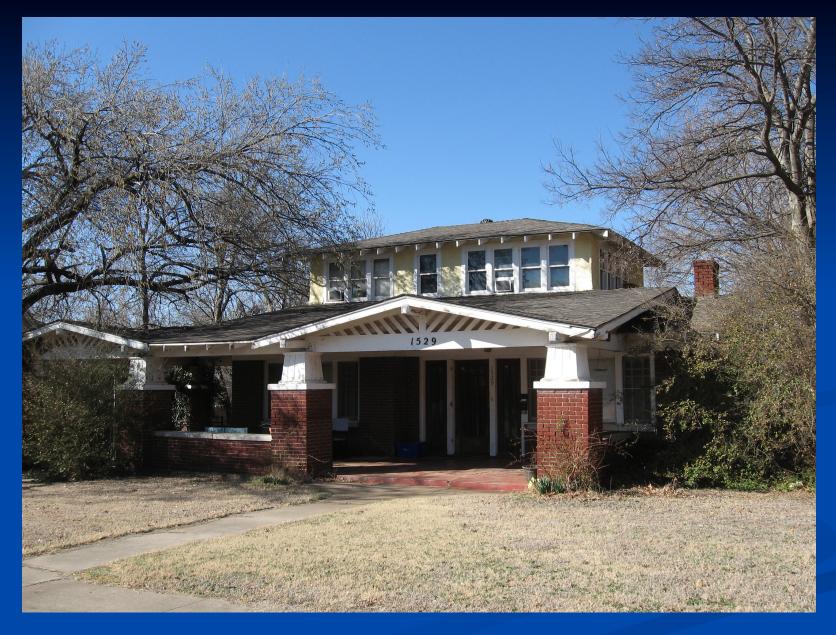
**Inherent Energy Conservation – Wide Roof Eaves**

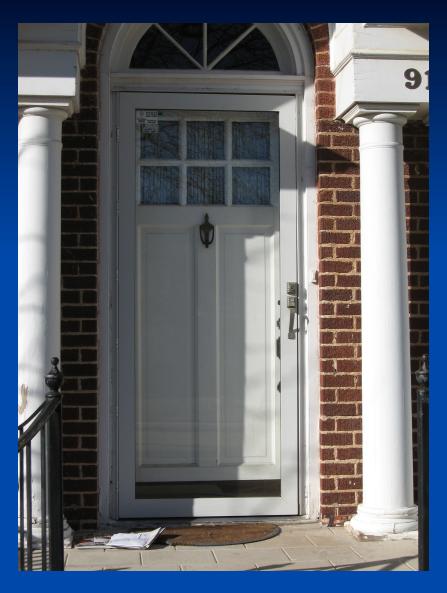
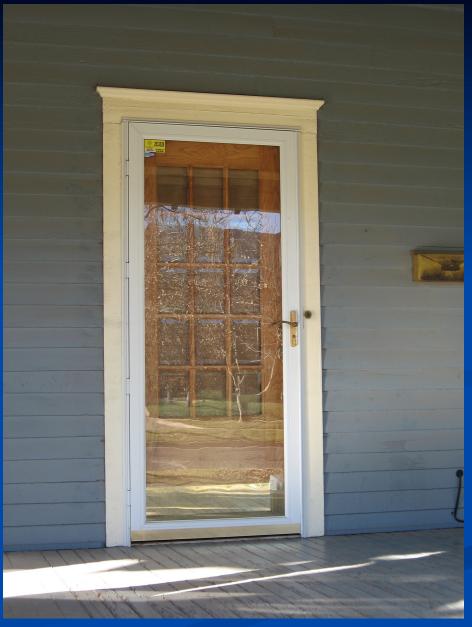
**Appropriate Design Storm Doors**

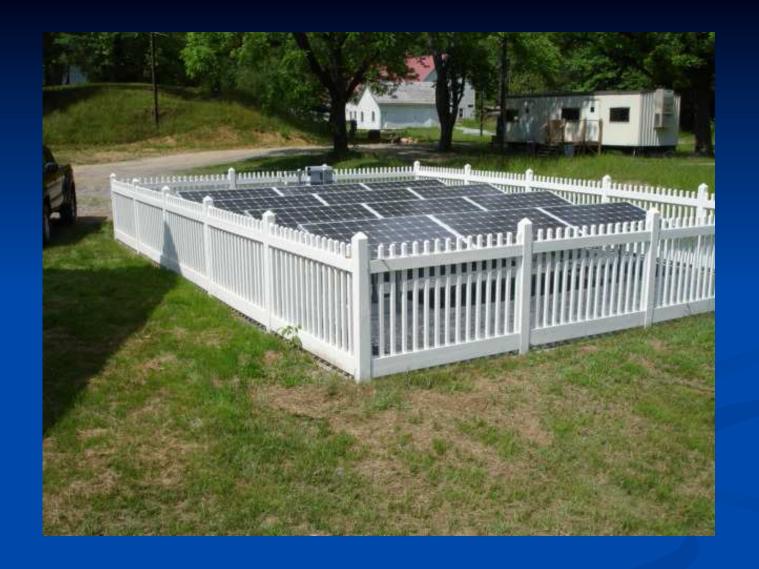
Freestanding Solar Panels in Rear Yard with Screening

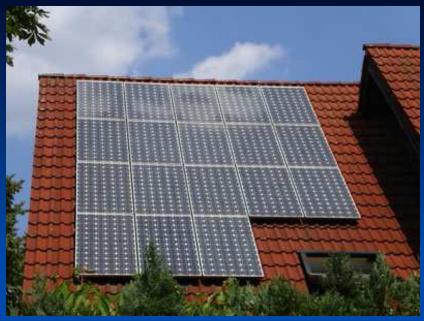
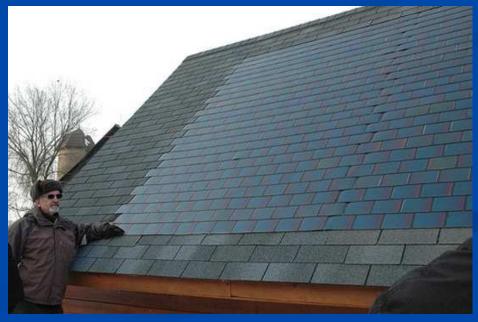
Rear Roof Line Solar Panels (Above) and Solar Shingles (Right)

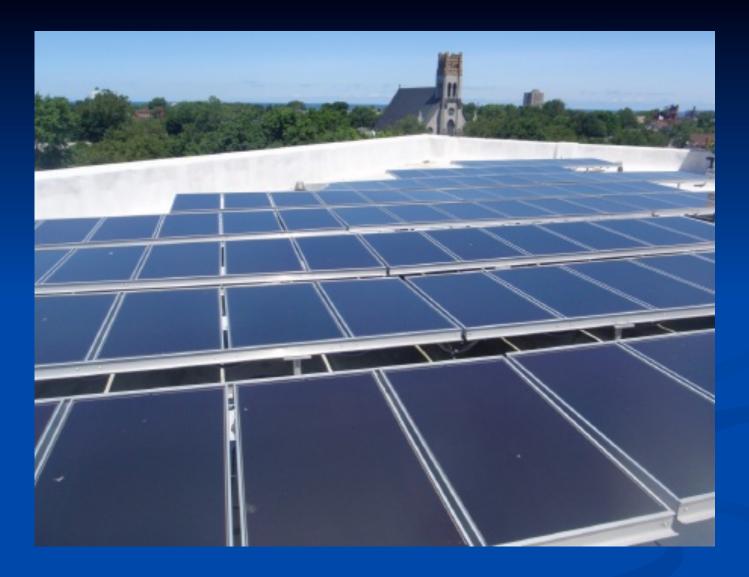
Retrofitting Commercial Buildings – Rooftop Solar Panels

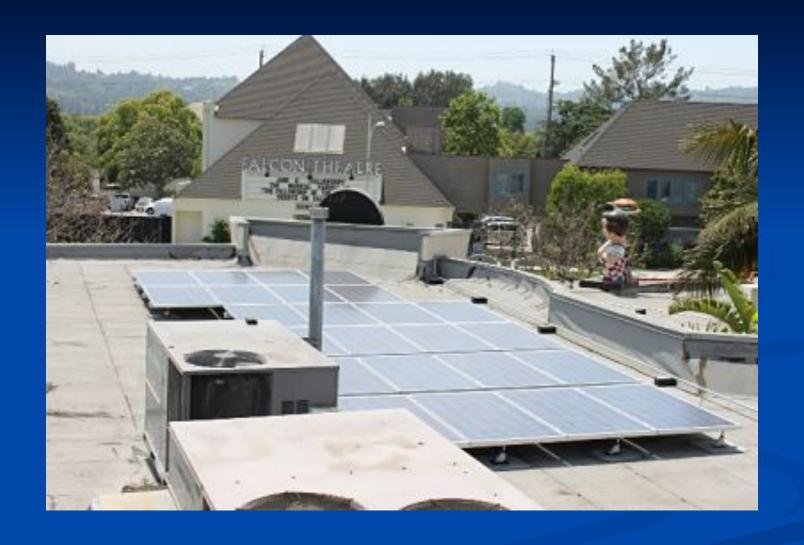
## Retrofitting Historic Commercial Buildings - Rooftop Solar Panels

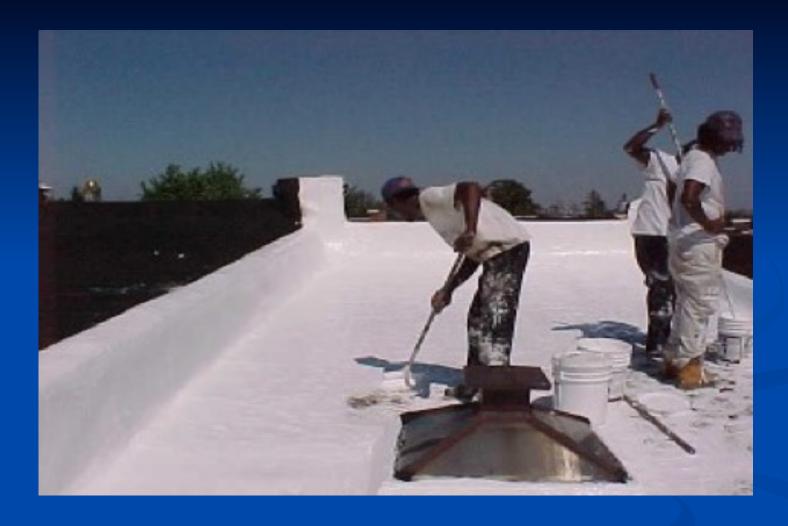
## Retrofitting Historic Commercial Buildings - Reflective Roofs

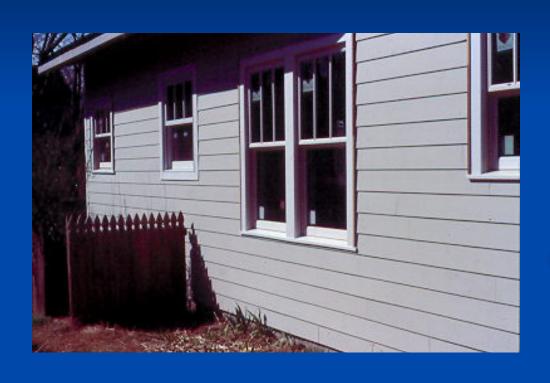
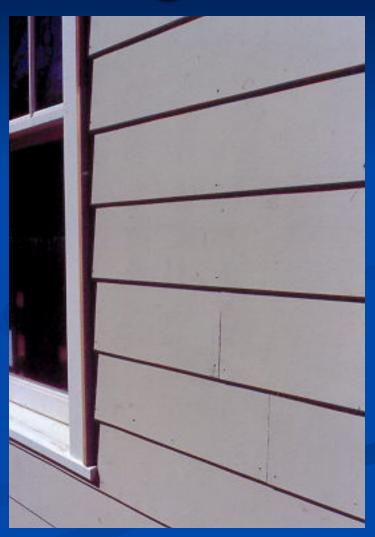
### Cementitious Siding

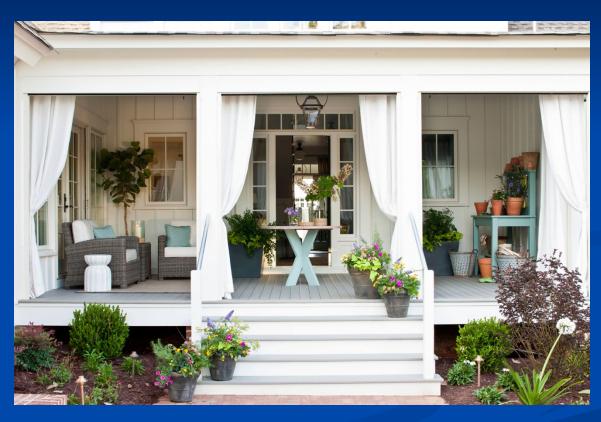
### Composite Porch Floor

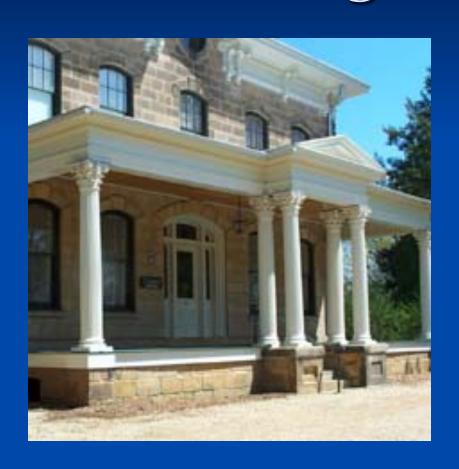
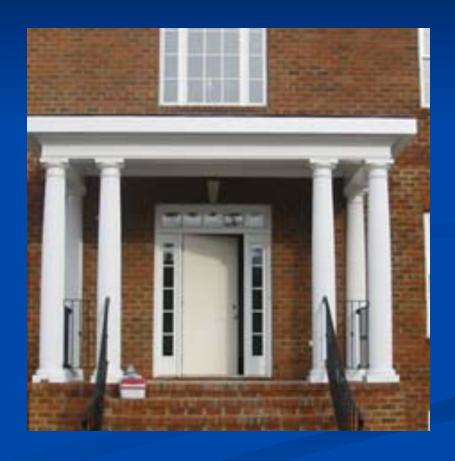
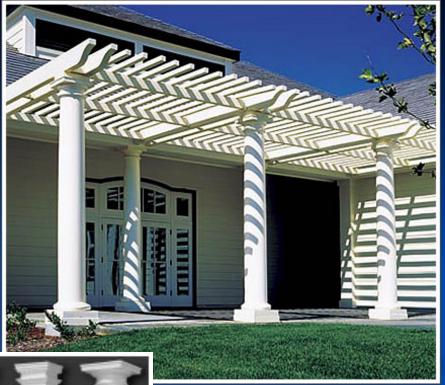
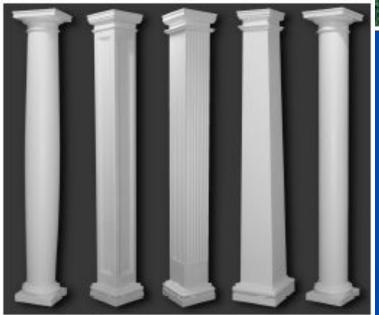
Fiberglass Columns

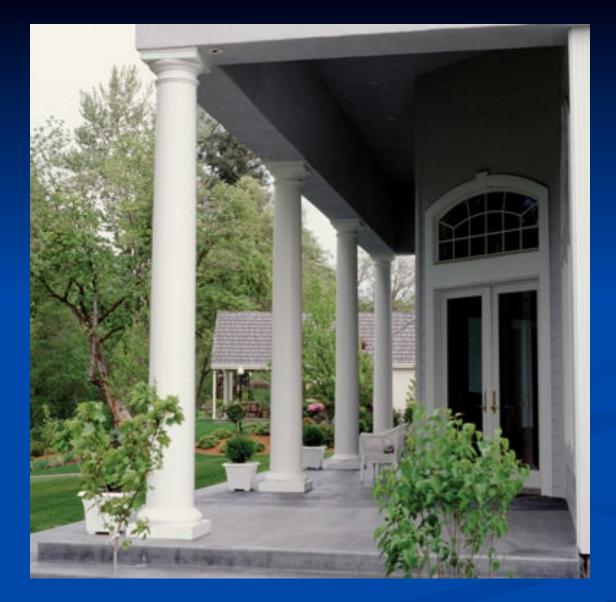
Fiberglass Columns

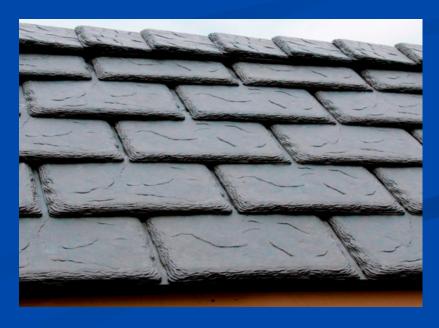
### Roof Materials – Synthetic Slate

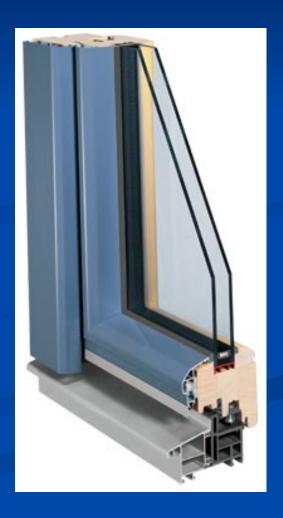
# Aluminum Clad Wood Replacement Windows: Longevity/ Maintenance

- Advantages
  - Can Have Compatible Profile and Appearance
  - Longer Life Expectancy Than Vinyl Windows
  - Can Meet NPS and Local District Guidelines
- Disadvantages
  - Comes From New Growth Wood and Aluminum Less Sustainable
  - Appearance May Lack Some Aspects of Compatibility

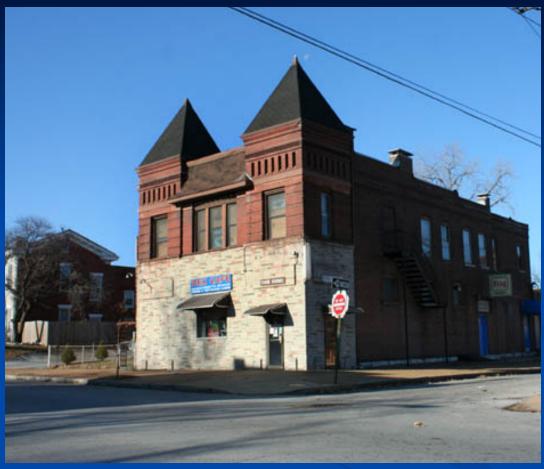
Difficulty of Repair of Materials, ca. 1950 – ca. 1970 Formstone and Permastone

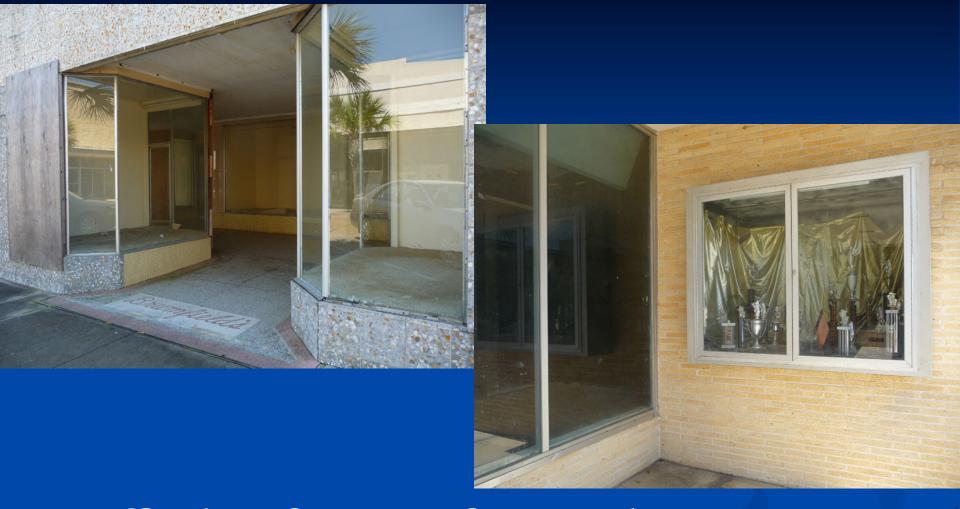
Difficulty of Repair of Materials, ca. 1950 – ca. 1970 Tile and Roman Brick
